# BITS: TECH NOTE

## Chasing Exhaust Odors in 105 & 115 Cars

Erik Roe, AROO  
March, 2006

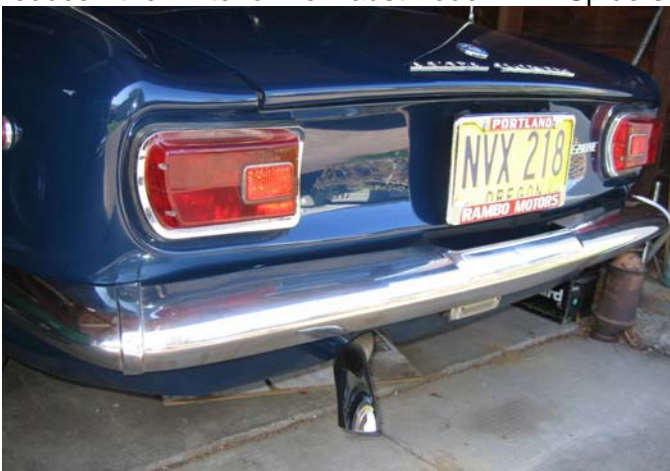
Thinking the tail pipe might be the issue, I had the mufflers replaced and a downward pointing tail pipe tip installed. Alfa had released a factory bulletin in the early 1970s that this type of exhaust tip will reduce the interior exhaust odor in Spiders.

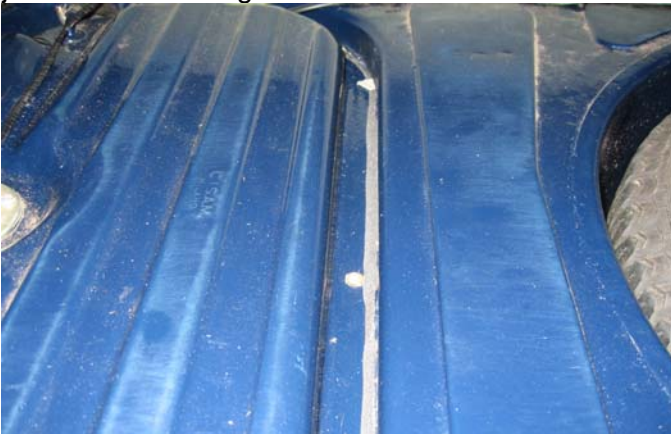
What I found was that the gas tank flange seal (gasket) was not sealing well at all. I did a seal test by pouring water around the tank perimeter (onto the flange, a quick easy test) and noted the water just ran out to the ground – no seal!

Due to the poor tank flange seal, (small gasket) the carbon monoxide level (traveling at 60 mph) was running well over 100 ppm in the trunk and interior with the driver's window cracked (draws trunk air into interior). I pulled the gas tank out and re-installed it with a 3/8" thick, 3/4" wide closed cell foam rubber gasket. The CO measurement dropped to 16 ppm in the trunk, but, I got a "zero" reading in the interior of the car. A huge improvement. If I had the right type of body caulk, I would "glue" the tank in, but the thick gasket worked fine. My next step is to improve the trunk lid seal. Exhaust residue on the underside of the lid indicates the leak paths.

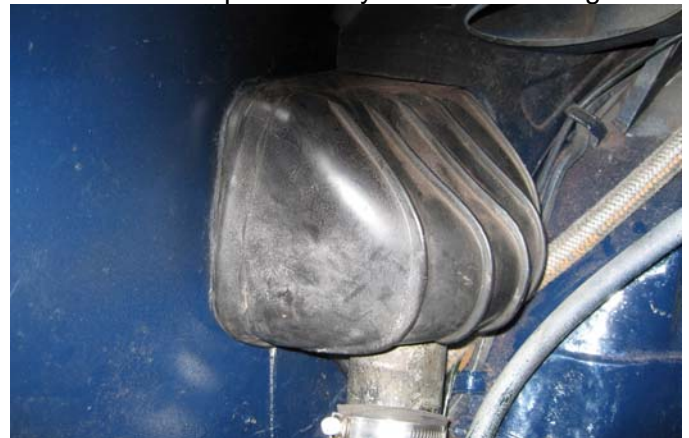
Ensure this boot is installed, not torn and that the drain feature is properly routed and caulked.
